# Manhole Inspection Summary

Manhole # S71E\_\_007MH

Insp Date: **5/27/08 11:11 AM**

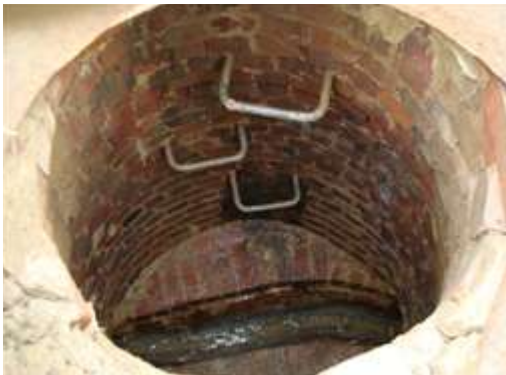
Defect 2

Infiltration: ☐ None ☒ **Joint** ☐ Cracks ☒ **Mortar** ☐ Roots ☐ Wall

infiltration

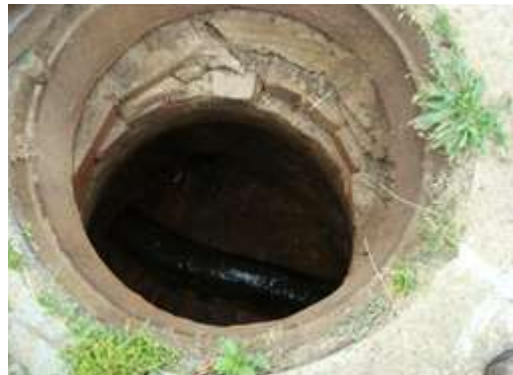
Defect 1

Condition: ☐ Sound ☐ Cracked ☐ Root Intrusion ☒ **Loose Brick** ☐ Deteriorated

deterioration

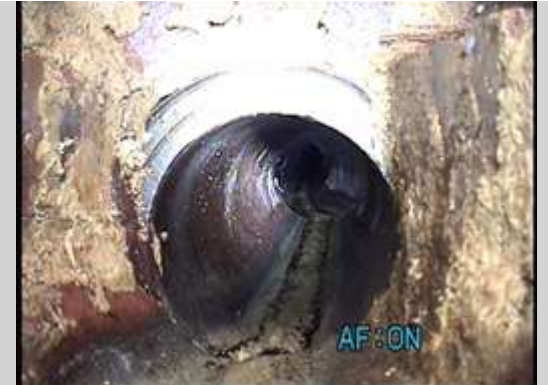
12 O'Clock Outflow

8 in. Circular Gravity Sewer  
Pipe Out @ 12 O'Clock

Pipe Height: **8.4** (in.) Rod and Bar (Angled)  
Pipe Material: **Clay** ☐ Pipe Lined  
Invert Depth: **7.70** (ft.) Flow Characteristics: **Fast**  
Deposits: ☒ None ☐ Mud ☐ Sludge ☐ Debris ☐ Grease  
Silt Depth: (in.) Deposits Extent:  
Infiltration: **None** Pipe Seal Cond: **Sound**

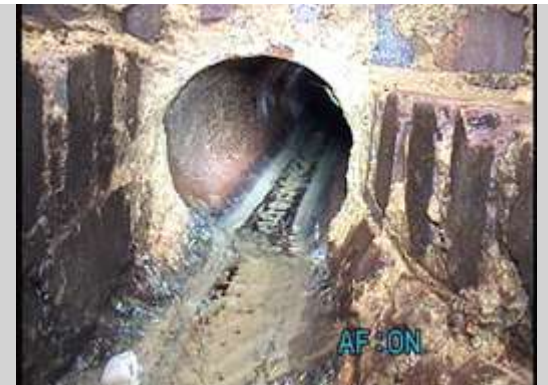
6 O'Clock Inflow

8 in. Circular Gravity Sewer  
Pipe In @ 6 O'Clock

Pipe Height: **8.4** (in.) Rod and Bar (Angled)  
Pipe Material: **Clay** ☐ Pipe Lined  
Invert Depth: **7.50** (ft.) Flow Characteristics: **Fast**  
Deposits: ☒ None ☐ Mud ☐ Sludge ☐ Debris ☐ Grease  
Silt Depth: (in.) Deposits Extent:  
Infiltration: **None** Pipe Seal Cond: **Sound**
